Bearing indication on a high speed separator after close to 48 000 hours in operation

In a brewery a separator had been running almost 48 000 hours when MIVA® Master detected acute spindle bearing condition. Because of the early warning service could be carried out without loss of production.

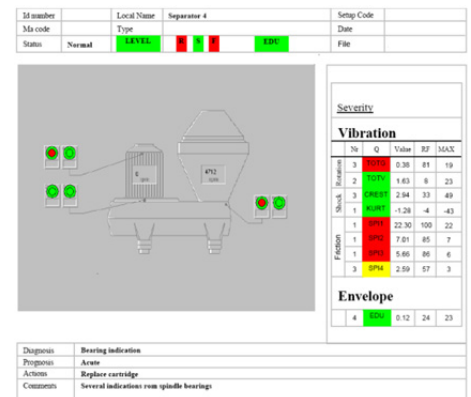
One week later, July 8, the system had detected acute condition and identified distinct symptoms from damaged spindle bearings. A report was issued with recommendations to replace the spindle cartridge. This report is shown below.

Symptoms were mainly seen on the 6315 and 7315BE spindle bearings. The defective bearings were highlighted with red in the K-model report. The picture below shows the K-model report from July 18 with comments on how it should be interpreted.

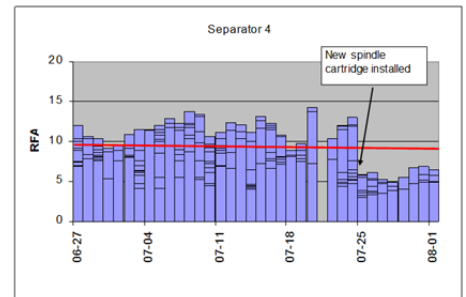
RFA Trend

Support for our decision to recommend change of cartridge is that we had observed a drastic change in machine condition in June relative the condition at the beginning of the year. The diagram show RFA values before and after the cartridge was replaced.

The red line is the upper limit for normal condition. Each bar represents RFA values over one day. Variations over the day is shown with a horizontal line inside the bar.

The level dropped significantly below the red line after the cartridge was replaced.
