Detection of gearbox oil contamination

A separator had been running good for a long time. After service in February gear and bearing indications suddenly appeared. A significant drop in bearing temperature could also be noted. An additional service action in the beginning of March managed to improve the condition temporarily but the underlying problem was not solved. At the end of March the condition deteriorated quickly. The MIVA® system provided accurate indications of the problem; gearbox oil contamination. This made it possible to plan and perform proper service actions in good time before breakdown. This case confirms that temperature measurements can be used to detect leaks and oil contamination. It also demonstrates the power of the RFA Trend and the Standard Machine Module.

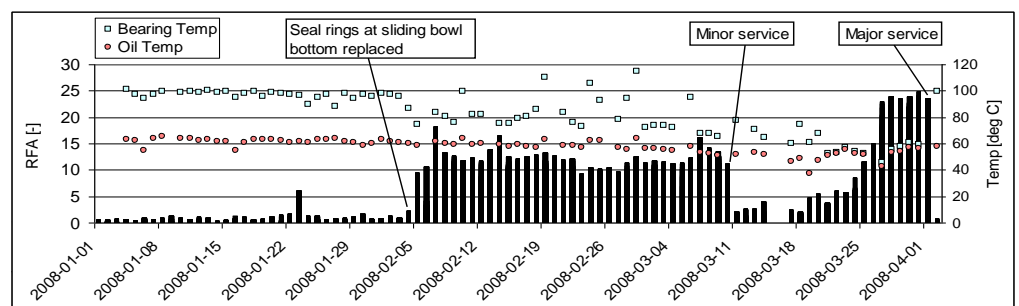
RFA and Temperature Trends

The diagram below shows the RFA and the temperature trends for Separator 1. The labels indicate the reported service actions. Note that the temperature readings are not included in the calculation of the RFA value. In this case the RFA Trend has proven to be an excellent measure of the overall machine condition. Also note that the bearing temperature provides a very early indication of incipient the problem.

The main problem in this case was contamination of the gearbox oil which damaged the bearings and caused increased gear vibrations. The contaminating liquid was probably leaking from the bowl. The drop in bearing and oil temperature indicate that the first leaks appeared after service at the 4 February. The next service improved the condition temporarily but did not solve the problem. Maybe the leak was sealed but the oil was already contaminated. This case confirms that temperature measurements can be used to detect product leaks and oil contamination at a very early stage.
